# CRREL

## REPORT 89-7

*Water detection in the coastal plains  
of the Arctic National Wildlife Refuge  
using helicopter-borne short pulse radar*

Steven A. Arcone, Allan J. Delaney and Darryl J. Calkins

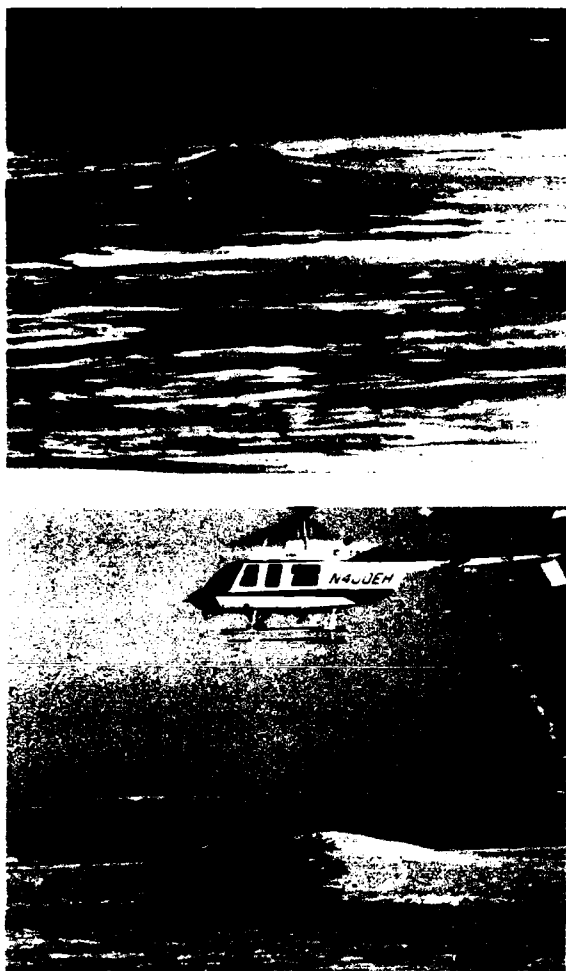
Figure 11. Longitudinal views down the long axis of mound 1.

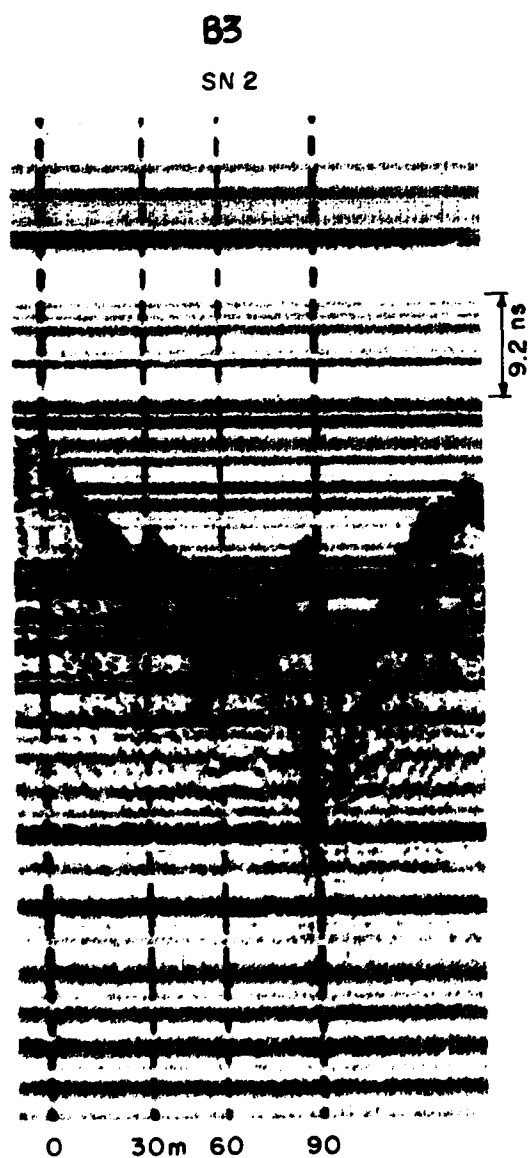
*Figure B4. Sadlerochit River, B3, B4.*

Transects B2 and B4 were run parallel over the top of the mounds. The radar returns indicate water beneath a long portion of the mounds. The estimated lengths where water was present are

The range in possible volumes of water above the gravel surface for mound 2 can be estimated based on the information from the radar surveys plus the one ground-truth water depth. The length of the unfrozen water zone from transect B4 is roughly 53 m. The range in widths is estimated at 5–10 m and a conservative depth is 1.2 m at the center. If a rectangular section along the entire length is assumed, then the total volume might be between 300 and 600 m<sup>3</sup>. The shape of the water cavity over the entire length is probably more elliptic than rectangular, based on observations of frost mound cavities and the expectation that the water depth would decrease toward the elongated ends of the mound. If a pyramidal section is assumed (with a height of 1.2 m) and one side is 53 m
